RYDE TOWN COUNCIL OFFICER REPORT

Committee:	Facilities and Assets
Date:	11 th October 2022
Report Author:	Liam Pearce
Report Title:	Vandalism at Eastern Gardens Toilets
Context:	On Friday 7 th October the Eastern Garden Toilets were vandalised. The incident was reported to RTC officers on Monday 10 th October.

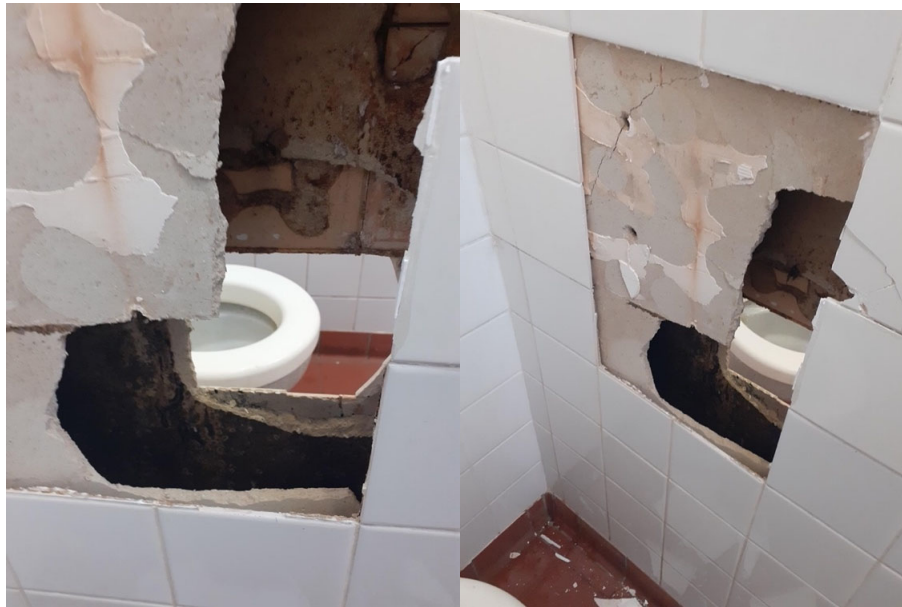
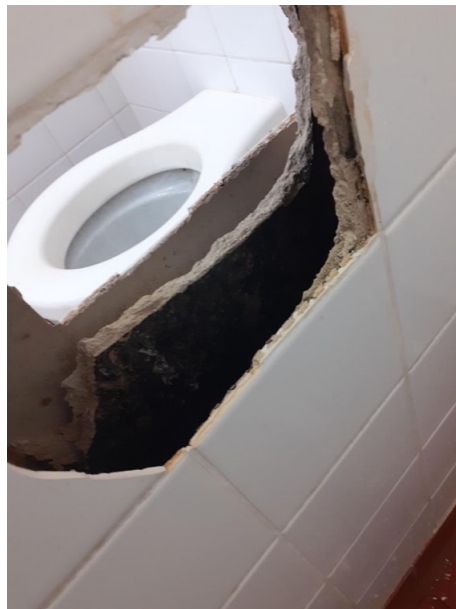
6. APPENDICES

On Friday 7th October the Eastern Garden Toilets were vandalised. The incident has been reported to police and quotations are being sort for remedial works in line with RTC's procurement rules. The damage includes demolition of party walls between some of the cubicles. (See accompanying photos)

The cubicles are constructed from timber studwork covered in plasterboard and tiled throughout with 6 inch white glazed tiles.

- I. Repair the damage as is, plasterboard covered with tiles to match existing and risk the same damage happening again.
- II. Remove the existing covering on the stud walls and replace with plywood which will be more resistant than plasterboard to this kind of damage and tile over to match existing tiles.
- III. Remove the existing covering on the stud walls and replace with plywood which will be more resistant than plasterboard to this kind of damage and tile over with a thicker contrast tile or stainless steel sheet. In addition, continue this at the same height all around the room

Option II

Remove the existing covering on the stud walls and replace with plywood which will be more resistant than plasterboard to this kind of damage and tile over to match existing tiles.
